# Manhole Inspection Summary

Manhole # S51M\_\_012MH

Insp Date: **12/22/08 2:05 PM**

**Location** Address: **rear 823 s lakewood av**

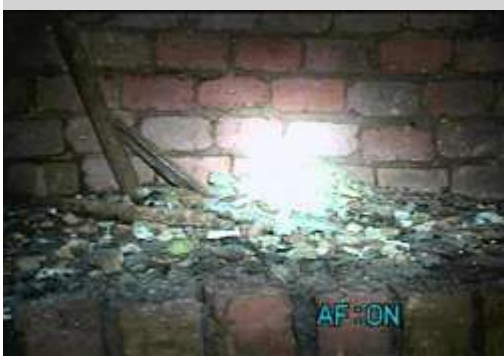
Miscellaneous

bench debris

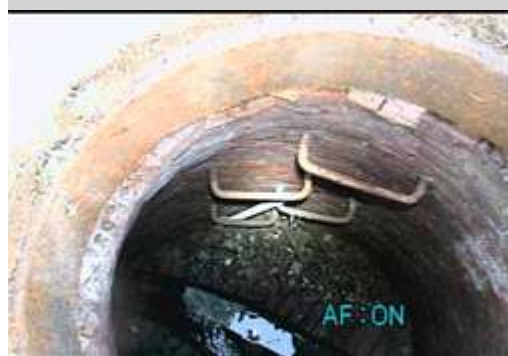
Defect 2

**Steps** Count: **4** Missing: **0** ☒ **Corroded**

steps corroded

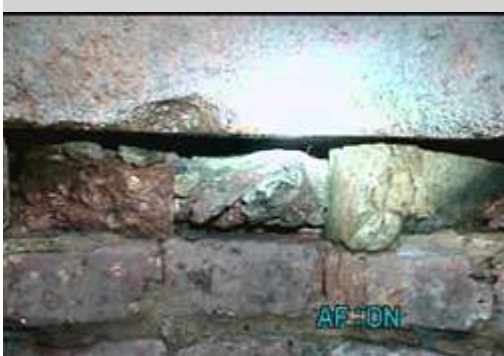
Defect 1

Condition: ☐ Sound ☐ Cracked ☐ Root Intrusion ☒ **Loose Brick** ☒ **Deteriorated**

chimney loose bricks deteriorated at frame joint
